The Old Rectory, Carshalton: a historical survey

Address	The Old Rectory, Festival Walk, Carshalton SM5 3NY
Grid ref	TQ 277 645
Authors	John Phillips and Sue Horne
Date of investigations	6 April 2009, 14 and 20 August 2015
Revised	24 May 2019

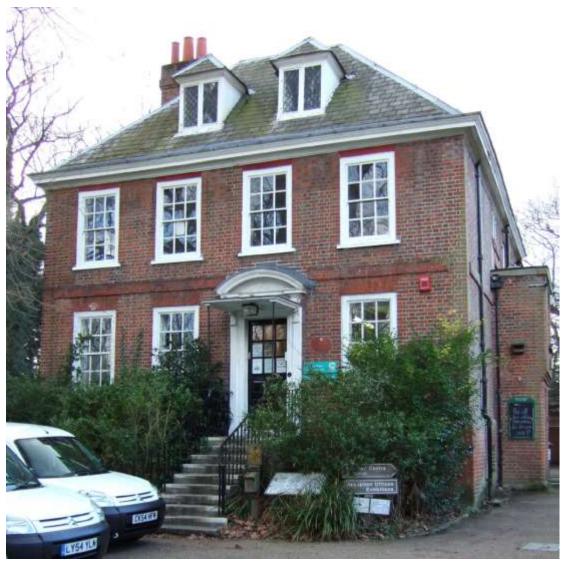
Figure 1. The east side of the house on 21 January 2006.

The east side is the front. It is four bays wide with the door off centre to the north. The wall has sash windows with rubbed brick heads. There is a projecting four course rubbed brick band at first floor level. There are two dormer windows with diamond shaped leaded lights. The basement windows are modern replacements.

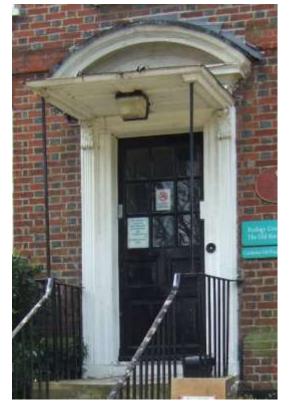
Figure 3.The side of the door frame.

The front door is approached by a flight of ten stone steps lined with plain iron railings and supported by brickwork. The door frame has a segmental head and cornice supported by foliate consuls above a fluted pilaster. There is a small flat porch which is attached to the door frame half way up the consuls and is supported at the outer end by two iron bars which rest on the hand rail of the steps. This is presumably an addition.

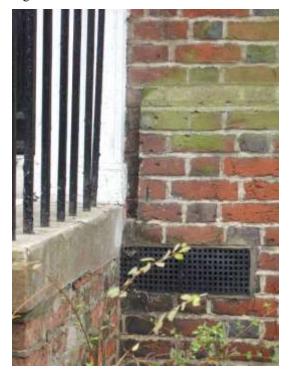
Figure 4. Junction of front steps and wall.

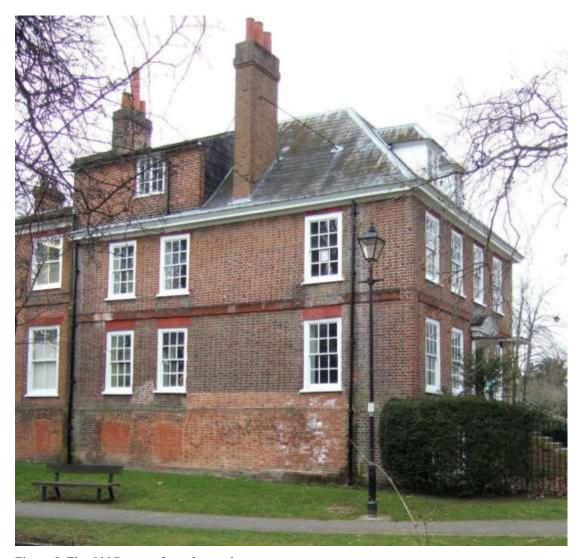
Figure 5. The Old Rectory from the southeast.

The south elevation falls into two parts: the original building and an extension added to the western side. The original building was four bays wide but the centre east bay has no windows as the space is taken by the chimney stack and fireplaces in rooms 2

and 11. The windows have straight heads with rubbed brick. There are two blocked segmental headed basement windows on the west side of the elevation. The east side has been refaced at this level and it is not clear if there were basement windows there. A large brick fronted dormer has been inserted into the west end of the roof. It has a casement window with a total of 12 lights and is probably 19th century. There is a band at first floor level and an offset above the basement windows.

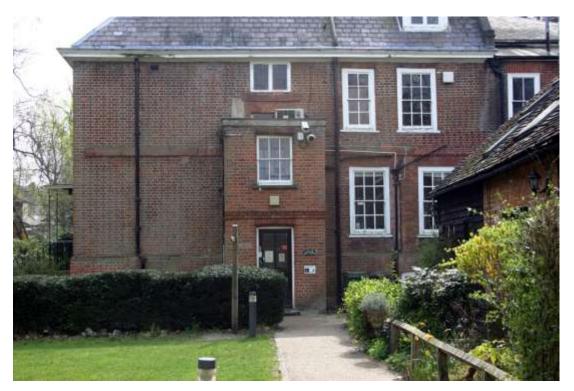
Figure 6. The north side of the house.

The original house was four bays wide. There are no windows in the eastern bay to accommodate the fireplaces and chimney in rooms 1 and 10. The chimney stack has now gone from the roof making the front less symmetrical.

The second bay from the east contained the staircase. This was lit by a small casement window immediately below the eaves and a large window below which is now partly obscured by the porch. There was presumably always an outside door at ground level.

There are four windows in the old building to the west of the porch, two on the ground floor and two on the first. The ground floor windows are the same size and are regularly spaced. The eastern first floor window is narrower the others allowing the adjacent window to be displaced eastwards. The reason for this is unclear. There is one segmental headed basement window at the west end of the original house.

The porch is a two story structure has which rises somewhat above the band on the original building. There is a door at ground floor level and a six light sash window above. The two are separated by a curious piece of corbelling three bricks high.

On this elevation the west extension falls into two parts: the main block which is set back and a narrow tower like structure in the angle between this and the main building. The north side of the 'tower' has a small window on the ground floor and a four light sash above. The west side contains a round headed door with a line of three corbelled out bricks above it similar to the porch. The north wall of the main part of the extension is plain brick.

The panelled wall between rooms 13a and 13b does not look like Council work to accommodate the toilets. The two rooms have their own windows which are different but from the outside they both look old (figure 6). It is possible that the wall between 13a and 13b originally divided the whole space and it may have been inserted fairly early in the house's history to create a dressing room to 12a. The corridor 13a was probably created later to provide access to the upper floor of the Victorian extension.

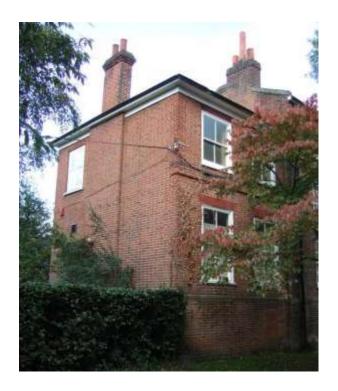
Figure 7. The extension from the southwest.

The west side of the original building is largely covered by the extension. The west side of the main part of the extension is of plain brick divided by a chimney stack which projects slightly in the centre. There is one casement window on the upper floor in the north of this and a basement door below it. There is no band at first floor level.

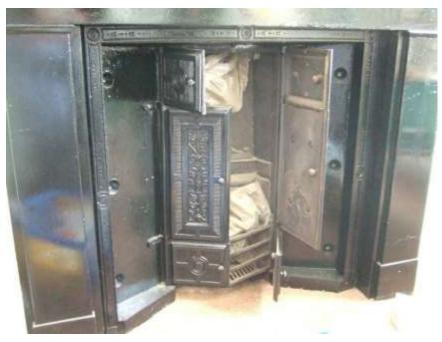
Figure 11. The cast iron grate in room 1a.

There is a fireplace in the centre of the north wall. The fire surround is of black marble or slate and looks early 19th century. It is now painted black. Within this there is a cast iron grate with six doors which are designed to convert it from an open grate to a stove. I have not found a close parallel for this but a Victorian date is likely. There is a walk-in cupboard built into the niche on the west side of the fireplace. It projects forward of the chimneybreast. There is a row of coat hooks on the east side. The shelves look modern. The cornice runs around the top of the cupboard and the dado rail runs across the door so it is probably original. There is also a cupboard on the east side. This does not look original but the coving respects it and it is hard to see the space without one. The window surround projects inwards from the wall. The sashes are modern. The doors to the shutter boxes are split into two parts, upper and lower.

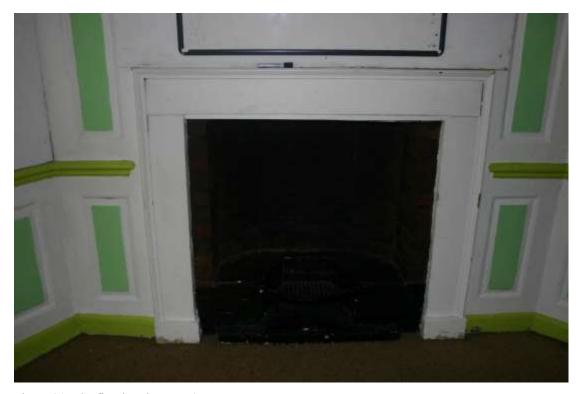
Figure 21. The fireplace in room 2.

There is a fireplace in the southwest corner of the room. The surround has been painted but is probably of white marble with grey veins. The bricks around the grate

are marked 'EJ & T PEARS LIMITED STOURBRIDGE'.

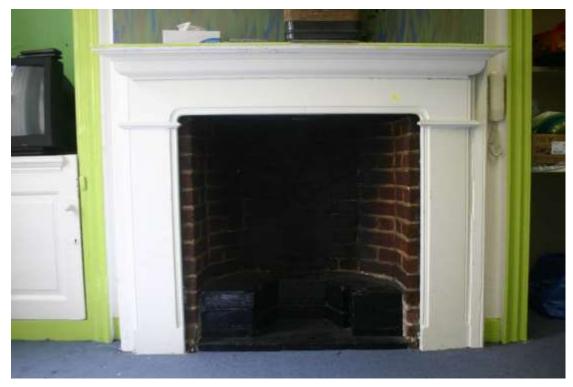
Figure 23. The fireplace in room 3.

There is a fireplace in the centre of the west wall. The chimney projects into the room. There is a wood lined arched niche to the south of it. The bottom of the niche is level with the dado rail and there is a cupboard below. The dado rail continues onto the top of the cupboard door. There is a tall cupboard on the north side of the chimney which now lacks doors. The mouldings are similar to the door between room 1a and 2.

The fire surround is painted probably over white marble. The design looks early 19th century. The heavily moulded mantle shelf is probably an addition. The hearth is modern.

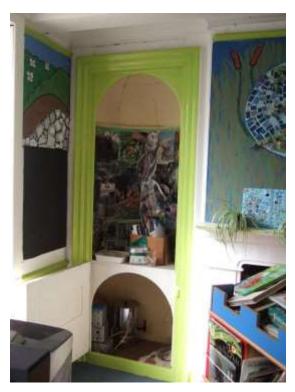
Figure 26. The niche and cupboard in the southwest corner of room 3.

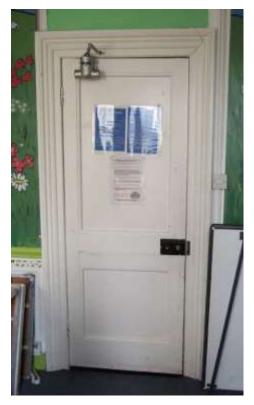
Figure 29. The door between room 3 and room 4b seen in room 3.

There are two doors in the north wall, one to room 4b and another narrower blocked one to the stair well. The frame of this has a simple roll moulding. The door into 4b is divided into two panels respecting the room panelling but the dado rail does not continue across it. The mouldings are different than the door between 1b and 2.

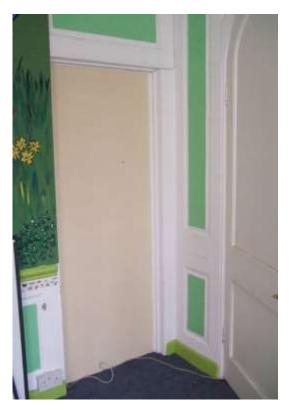
Figure 30. The blocked door between room 3 and 4b seen in the stairwell.

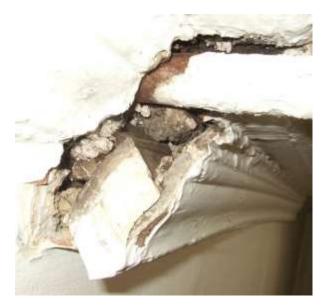
Figure 34. Detail of the coving above the east most window of room 3. The upper part of the coving is on a wooden plank set at about 45 degrees.

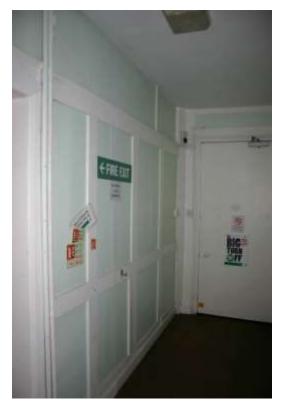
Figure 35. Panelling on the south wall of room 4b.

The wood panelling survives in good condition along the south side of room 4b. It extends up to the top of the door and is divided by an undecorated beam at dado rail height. The picture rail at the top appears to be modern. Panelling also survives on parts of the north and west walls of room 4a.

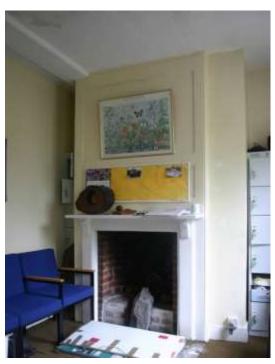
Figure 36. The fireplace in room 4a.

There is a fireplace on the west wall of room 4b. The panelling above it appears to be original but the grate has been rebuilt and the mantle shelf has Jacobethan bosses and brackets which are likely to be late Victorian or Edwardian.

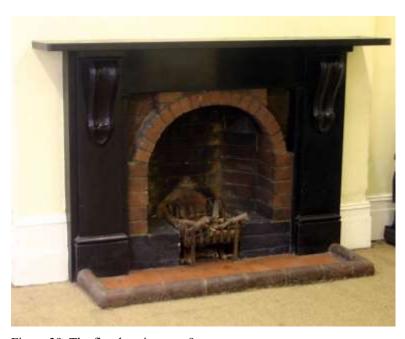
Figure 39. The fireplace in room 9.

There is a large black marble fireplace off centre on the west wall. It has a shallow grate similar to the ones in rooms 2 and 3.

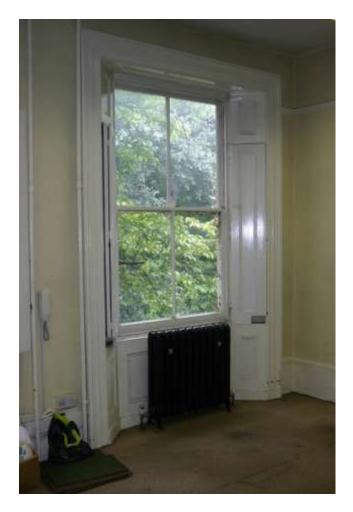
Figure 41. The western window in the south wall of room 9.

There are two large four light sash windows in the west wall. The one on the west side has a deep wooden surround. This is absent – presumably removed – on the east side. The shutters are cut to fit cast iron radiators.

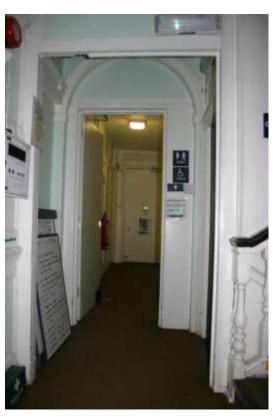
Figure 48. The ground floor stairwell looking west showing the inserted door frame at the stair turn.

The door at the head of the cellar stairs is probably an insertion as is the panelling down the centre of the stairs below it.

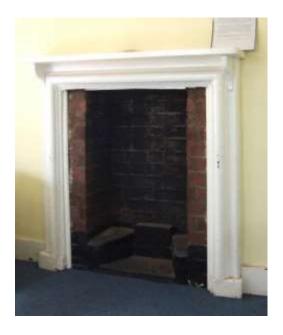
Figure 53. The fireplace in room 11.

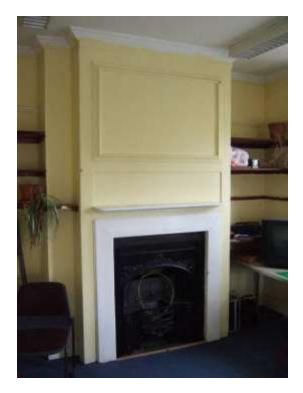
Figure 54. The fireplace in Room 10.

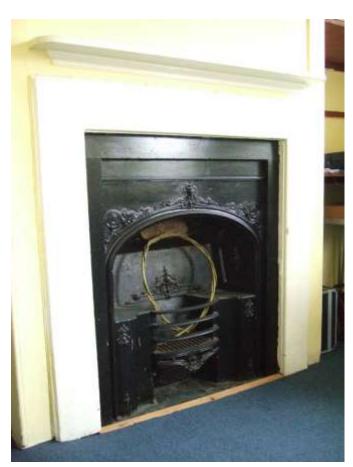
Figure 55. Victorian cast iron grate in room 10.

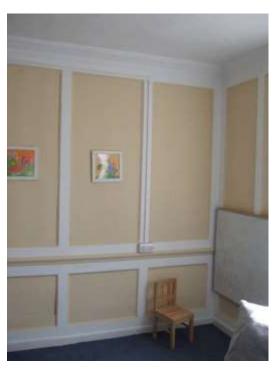
Figure 57. The panelling in room 12.

This room on the first floor in the southwest corner of the original building is exceptionally well preserved. It retains almost all its wooden panelling. There is a single line of large plain rectangular panels above the dado rail and another line of smaller ones below. The panels have a roll moulding around the edges. The top of the dado rail is 855mm above the carpet and the dado has a height of 78mm. The window frames project into the room and the coving steps in to accommodate them.

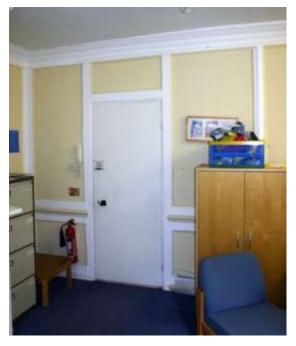
Figure 58. The door from room 12 to room 13c.

There is a door in the north wall opening to room 13c and another blocked one which led to the stairwell.

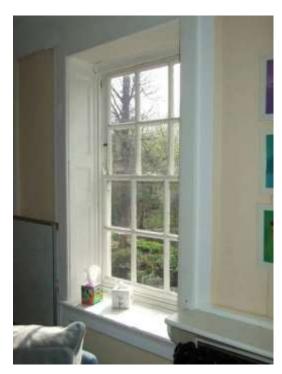
Figure 60. Window in Room 12.

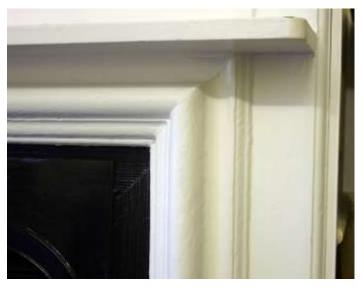
Figure 64. Detail of the fireplace surround in room 12.

There is a fireplace in the centre of the west wall with a wooden bolection moulded surround and a 19th century cast iron grate. This is in two parts – an outer cast iron fire surround with fluted decoration into which a decorative iron fireplace has been fitted. The latter is marked Cⁿ. C^o. probably for the Carron Company, Falkirk, Scotland and the back is marked N.4 F.12 perhaps indicating the size. The mantle shelf is probably an addition.

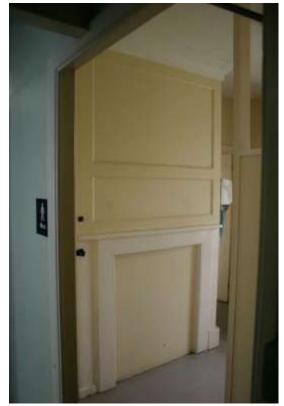
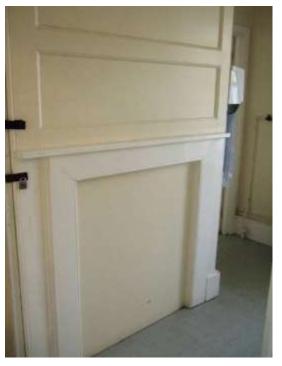
Figure 66. Above and left. The fireplace on the west wall of room 13a.

There is a chimney stack and fireplace against the west wall. This would have been off centre in the original space as there is a gap of 1.5m between the stack and the north wall compared with 2.06m between the stack and the south wall of room 13c. ¹⁵ The fireplace is blocked. It has a plain wooden surround with a roll moulding along the inner edge. There is a modern cupboard on the south side of the chimney stack.

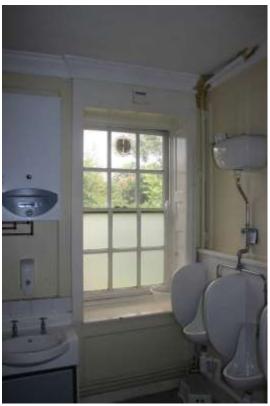
Figure 67. The window in room 13a.

There is window in the north wall of 13a with surviving wooden frame but no shutter boxes. The window surround projects into the room and the coving steps out over it.

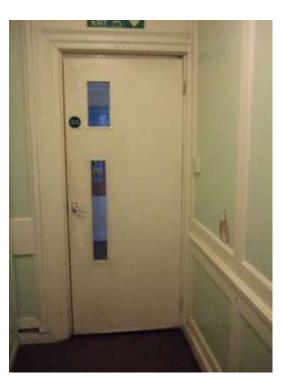
Figure 68. The door to the stairwell from room 13c.

There was a door from the stair into 13c. The original frame for this survives together with the panelling on the south wall which extends from floor to ceiling.

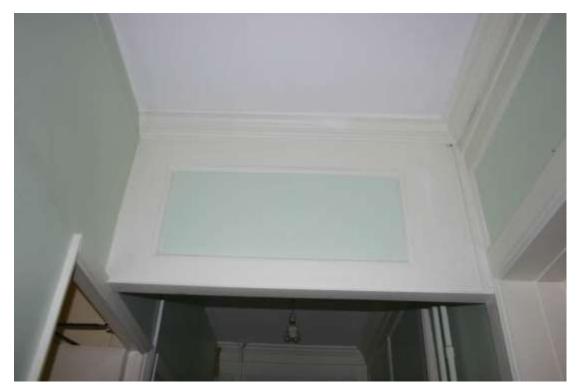
Figure 69. Partition in the upper part of room 13c. The door to 13b is on the left and to 12 on the right.

There is a north-south partition in the upper part of room 13a (figure 69). It does not align with the wall between 13a and 13b and its significance is unclear.

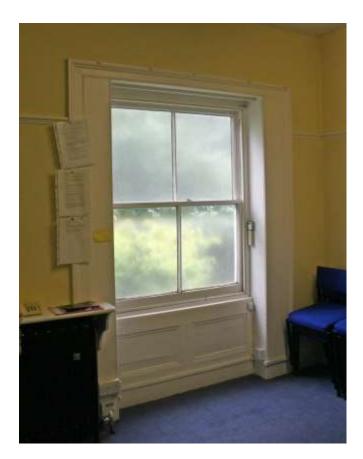
Figure 70. The western window in room 15.

There are two large four light sash windows in the south wall. Most of their woodwork survives although the western one is better preserved than the eastern. There were no shutters.

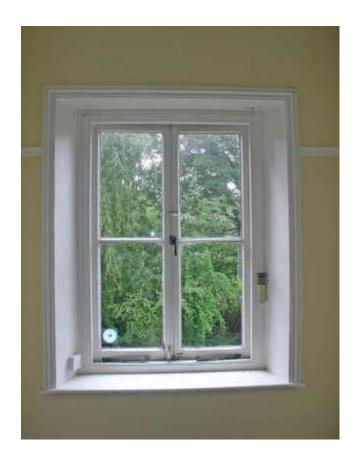
Figure 71. The window in room 16.

The room is lit by a four light casement window.

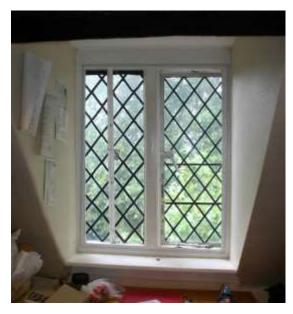
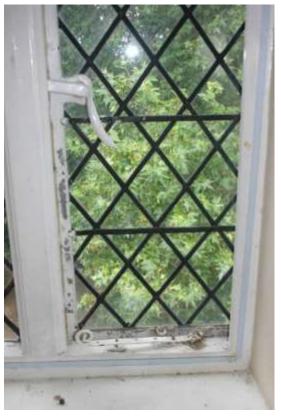
Figure 73. Above and left. The window in room 17

There is a dormer window on the east elevation. This has two lights with leaded windows set in a wooden frame. The northern light frame does not open and is divided by a vertical bar to which the leading is wired at intervals. The southern light opens. The latch could late 17th or early 18th century. The stay is fairly modern. There is a ring on the bottom of the window for a stay-hook which is now missing.

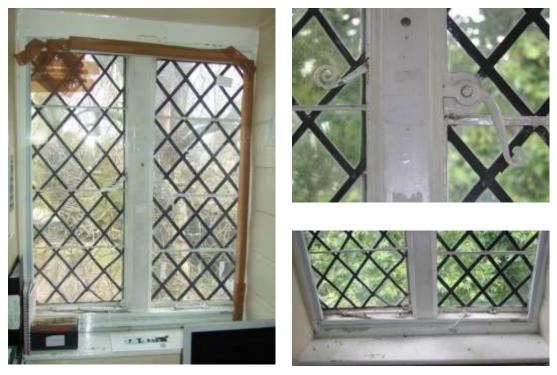
Figure 74. The window on the east side of attic room 18 with details of the latches and stays.

The eastern side is lit by a two light dormer window on the east elevation. The windows are leaded and the glass is supported by metal bars – three on each side. Both lights open. The window stay on the north side is fairly modern but there is an older stay hook on the south side. The spiral handles on the latches have some similarity to early 18th century examples in Hall and Alcock 1994 p. 33. There is a chimney stack with a blocked off fireplace against the south wall.

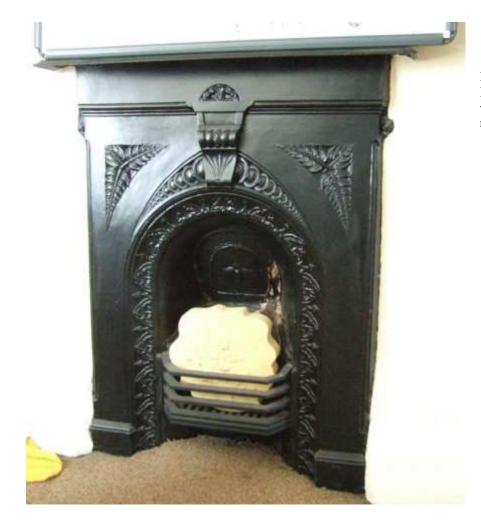
Figure 75. Fireplace on the west side of attic room 18.

have been reused. The stays are fairly modern. There is a chimney stack against the west wall with a very fine cast iron hearth.

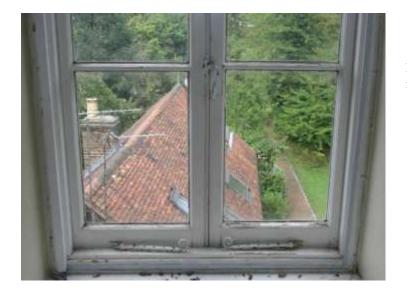
Figure 76. The window in attic room 19.

There is a 4 light casement window in the north elevation. It is likely to be an addition as it cuts the side purlin of the roof. The stays are fairly modern but the latch may be older.

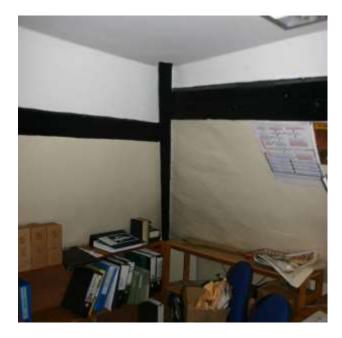
Figure 79. Timber at the northeast corner of the roof in attic room 17.

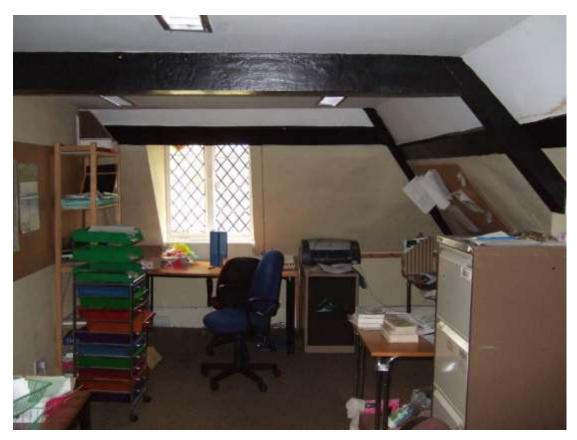
Figure 80. The roof timbers in the east end of attic room 18.

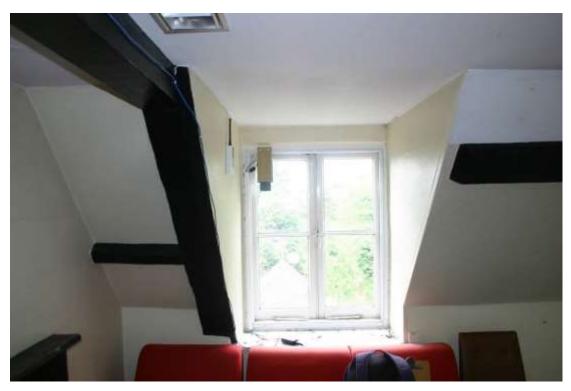
Figure 81. Timberwork supporting the west end of the north face of the roof seen in attic room 19.

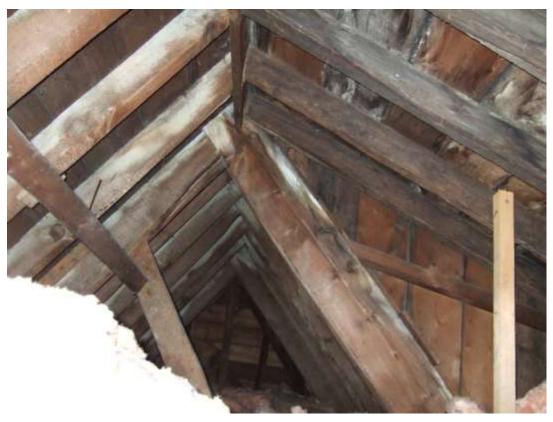
Figure 82. The roof seen through a trap door in the western half of attic rooms 18 looking east. The vertical boards to the right form the eastern side of the dormer. They may rest on a principal rafter.

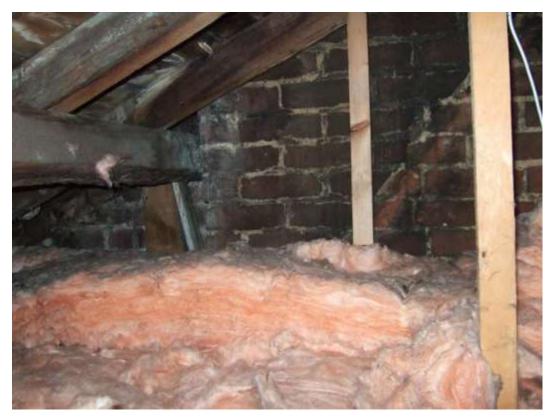
Figure 83. The western end of the south roof . The diagonal line on the brickwork of the chimneystack marks the original roof slope. The roof of the dormer can be seen top left resting on a reused timber.

The west end of the southern roof has been raised to accommodate the dormer extension in room 18.

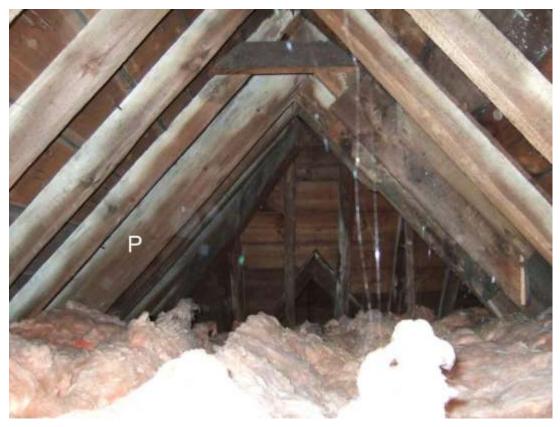
Figure 84. Looking east in the north side of the roof. The timber marked P is probably a principal rafter. The east slope of the roof can be seen in the background.

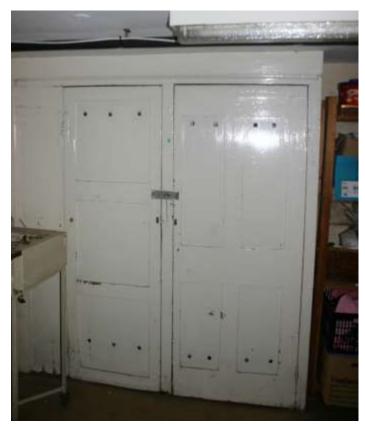
Figure 89. The cupboard in the south east corner of room 21 with a detail of the upper hinge from the left hand door.

There is another cupboard in the southeast corner of the room against the south wall. The doors appear to be reused and one has old hinges (figure 89). These are similar to

examples illustrated in Hall and Alcock 1994 p. 25 and Hall 2005 p. 53 which are dated to the late 17th and early 18th centuries.

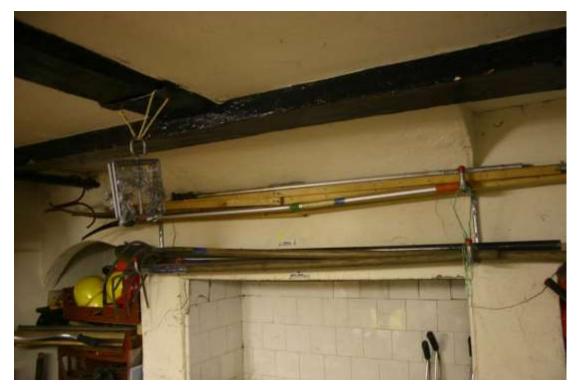
Figure 91. The bridging joist and cross beam on the west side of cellar 23.

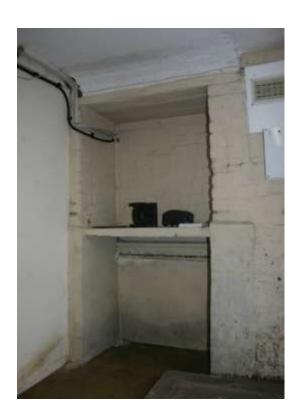
Figure 92. The niche in the south west corner of cellar 25.

There is a niche to the south of the chimney base with sandstone slab shelf. The top of the niche is made of wood with a curious little brick bracket at the front (figure 92).

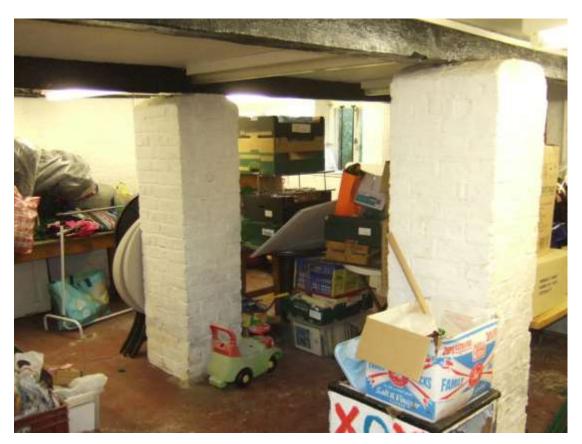
Figure 93. Cellar 26 looking southwest.
